**Western Fire Center, Inc.**

**Testing of Exterior Siding in  
Accordance with SFM Standard  
12-7A-1:  
*Fire Resistive Standards for  
Exterior Wall Siding and Sheathing***

**WFCi Project No. 09079**

**REPORT DATE: DECEMBER 28, 2009**

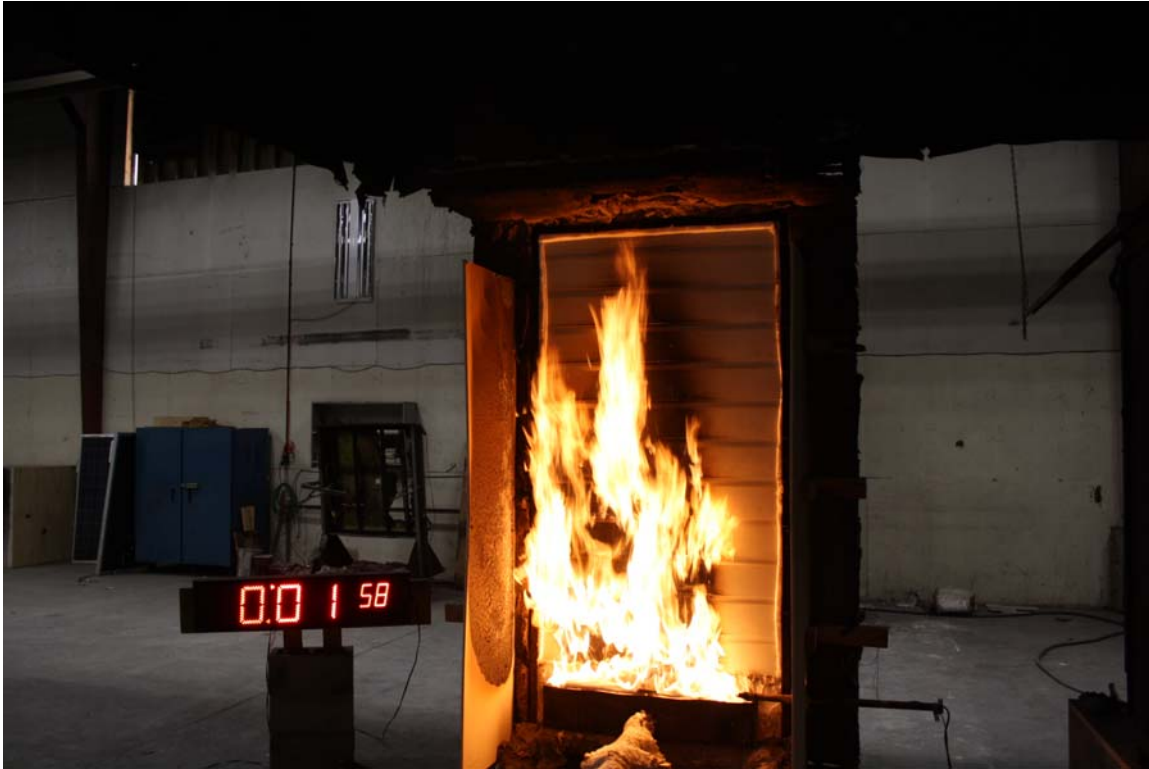
**Test 1, early in test**

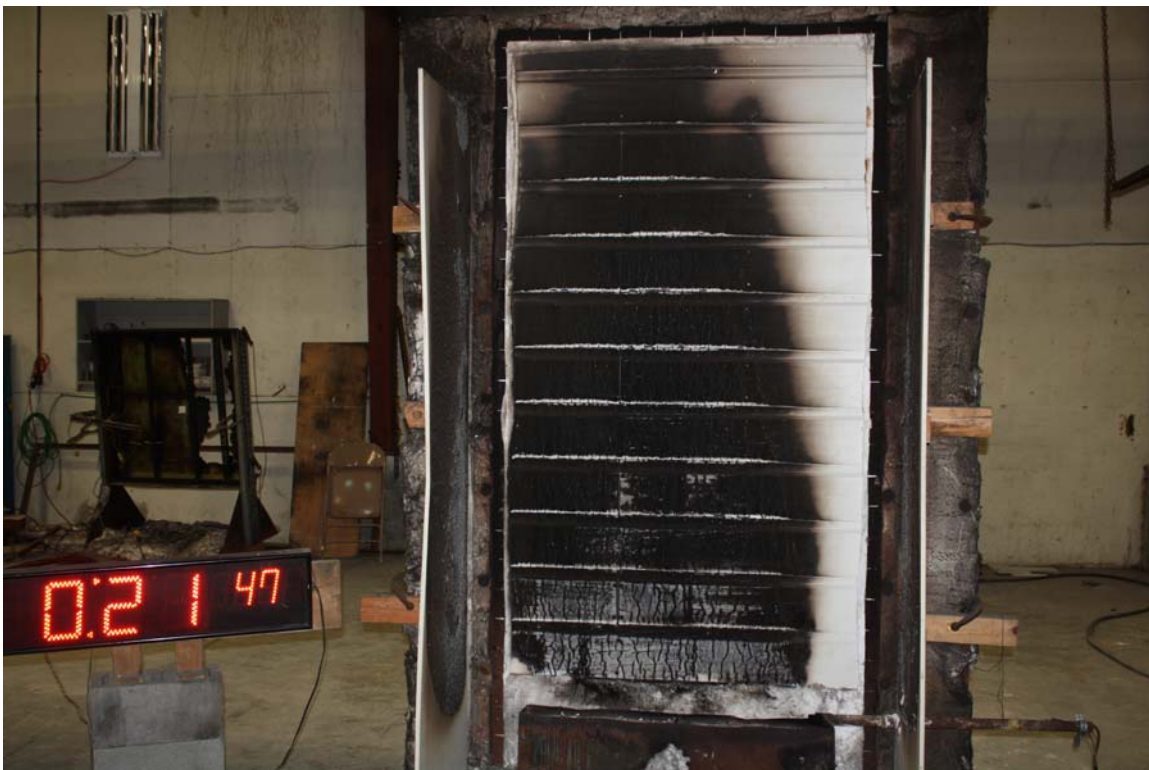
<b>Time</b>	<b>Observation</b>
0:00:00	Start Test, Ignite Burner
0:00:26	Ignition of panel
0:00:40	Flaming at soffit
0:10:00	Burner out- flaming continues at base of specimen
0:11:00	Flames out, some light glowing bottom right side on face
0:17:00	All glowing combustion ceased
0:20:00	Temperatures diminishing, No evidence of continuing combustion, stop test
Post Fire Exposure:	All signs of flaming and/or glowing combustion ceased at point of test termination; <b>no flaming or glowing combustion on unexposed side, test pass</b>
<b>Date</b>	10/20/09
<b>Burner Exposure</b>	150 kW
<b>Laboratory Temp/Humidity</b>	63°F / 62%
<b>Sample Moisture Content</b>	Siding 9%, sheathing 6-7%; studs 10%

**Test 1, at test termination**

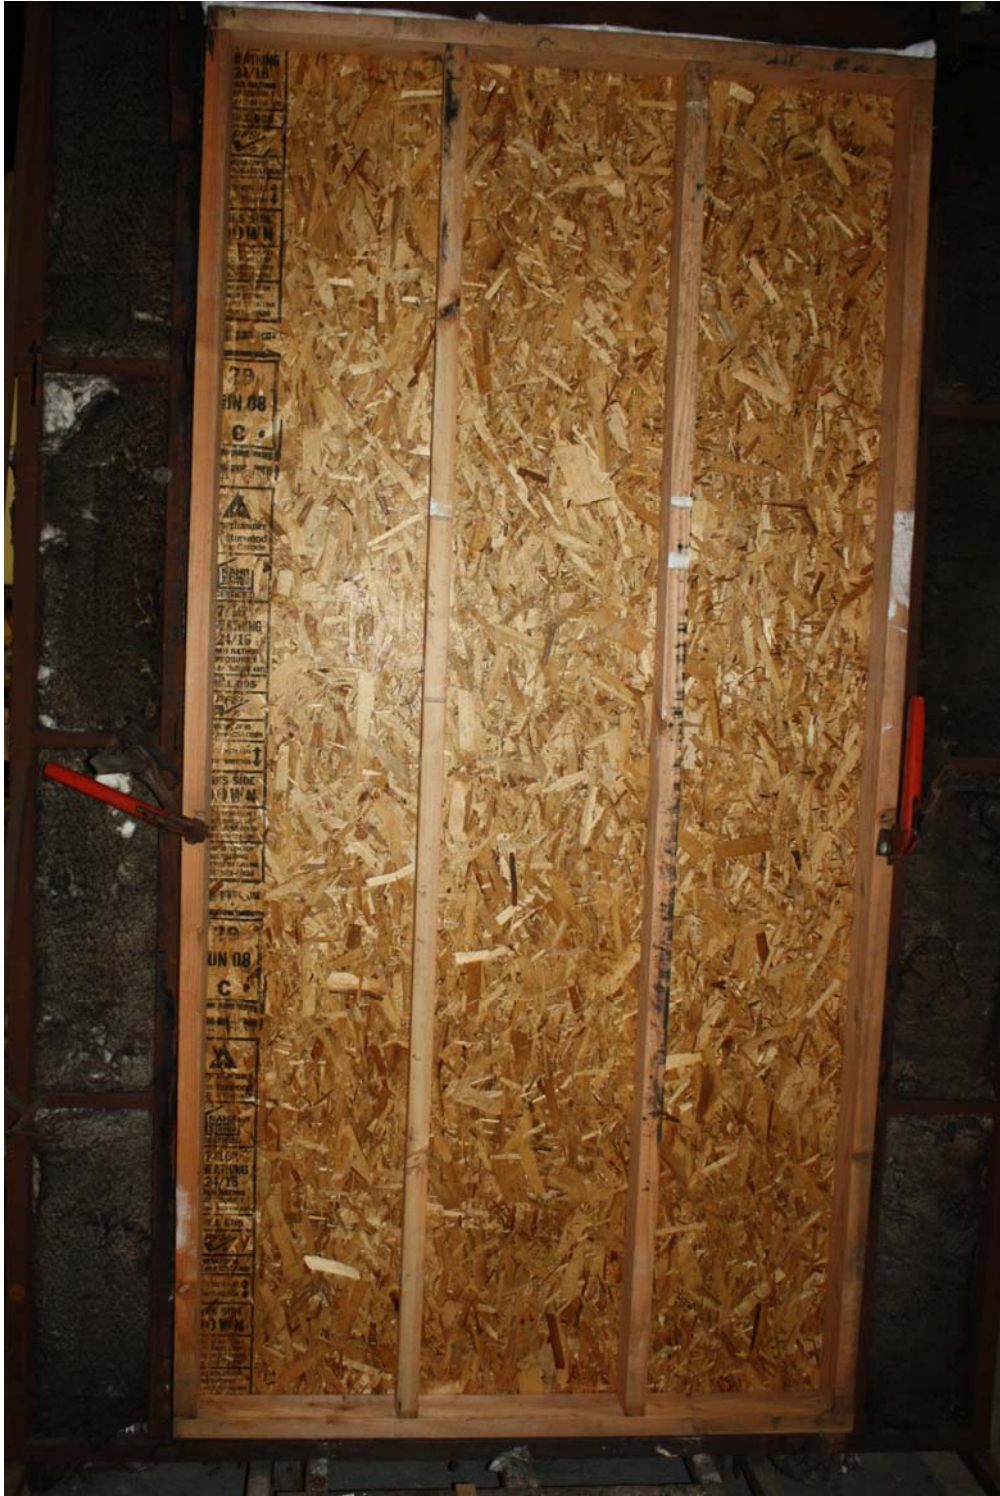
**Test 1, beveled channel, unexposed side at test termination**

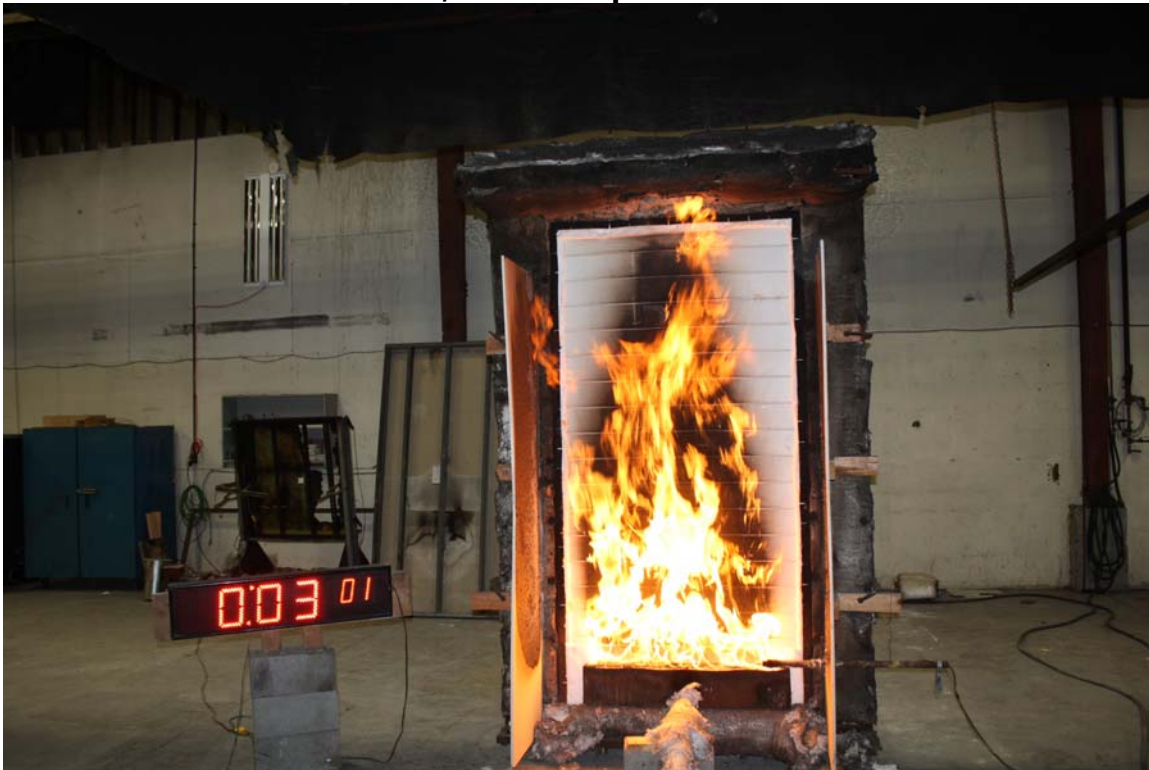
**Test 4, v-rustic early in test**

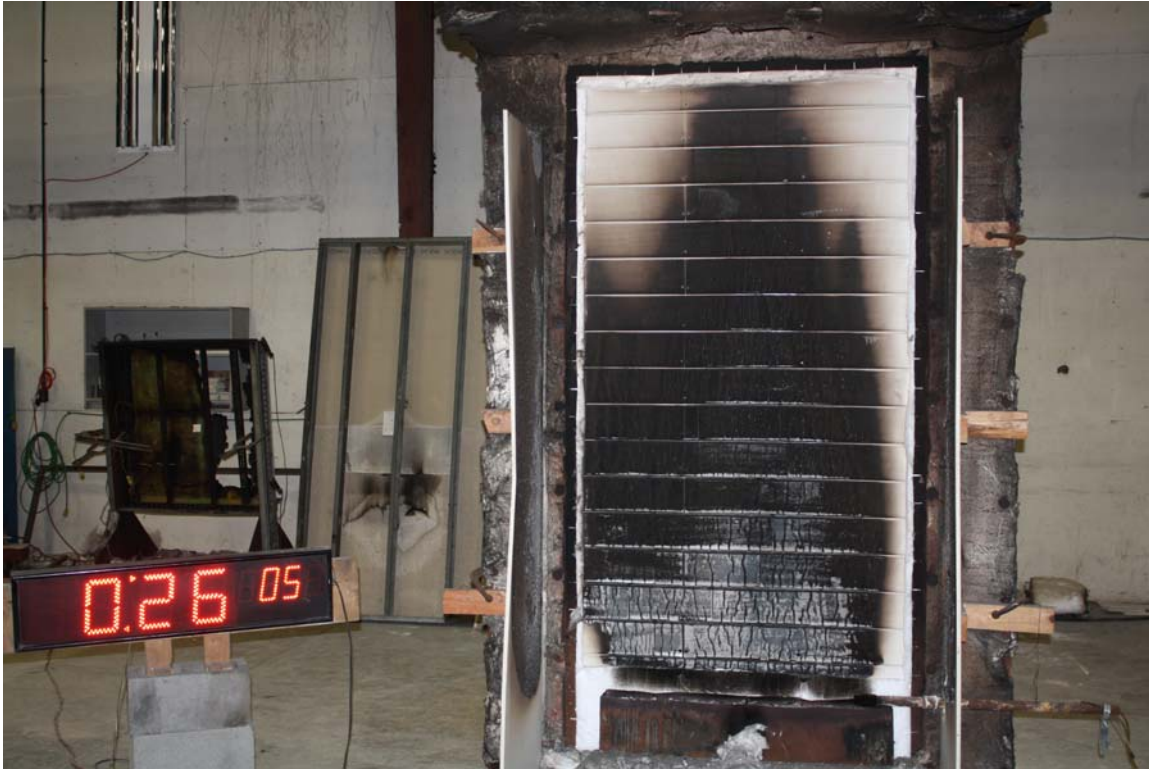
<b>Time</b>	<b>Observation</b>
0:00:00	Start Test, Ignite Burner
0:00:31	Ignition face
0:01:00	Flaming to soffit
0:10:00	Burner out- light flaming continues
0:11:45	Flames out, some glowing combustion on face
0:22:00	Glowing ceases, no signs continuing combustion
0:26:00	Temperatures diminishing, Stop test
Post Fire Exposure:	All signs of flaming and/or glowing combustion ceased prior to test termination; <b>no flaming or glowing combustion on unexposed side, test pass</b>
<b>Date</b>	10/21/09
<b>Slot Burner Exposure</b>	150 kW
<b>Laboratory Temp/Humidity</b>	62F / 66%
<b>Sample Moisture Content</b>	Siding 9%, sheathing 6-7%; studs 9%

**Test 4, v-rustic at test termination**

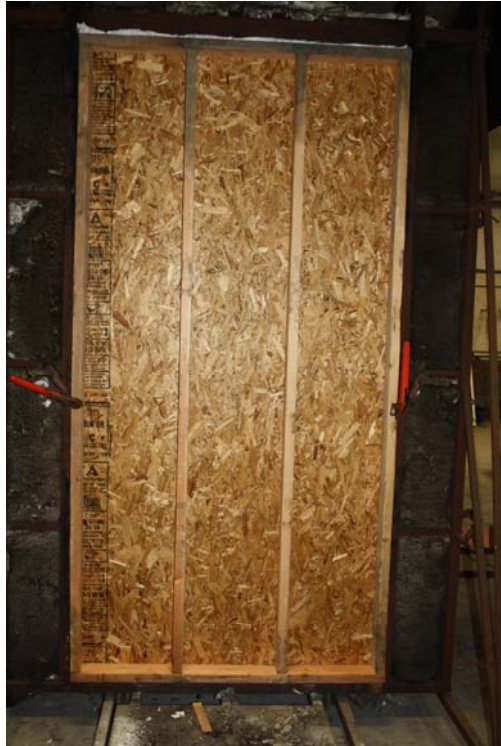
**Test 4, v-rustic unexposed side at test termination**

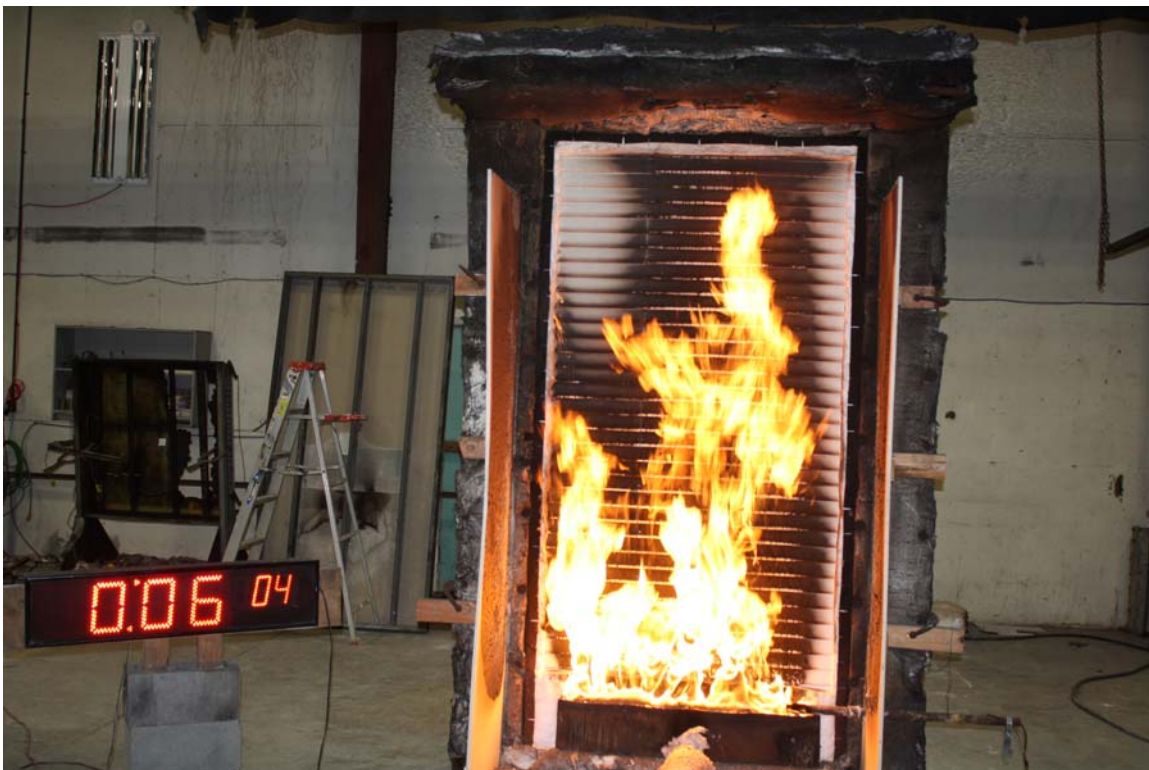
**Test 7, 3 lap during burn exposure**

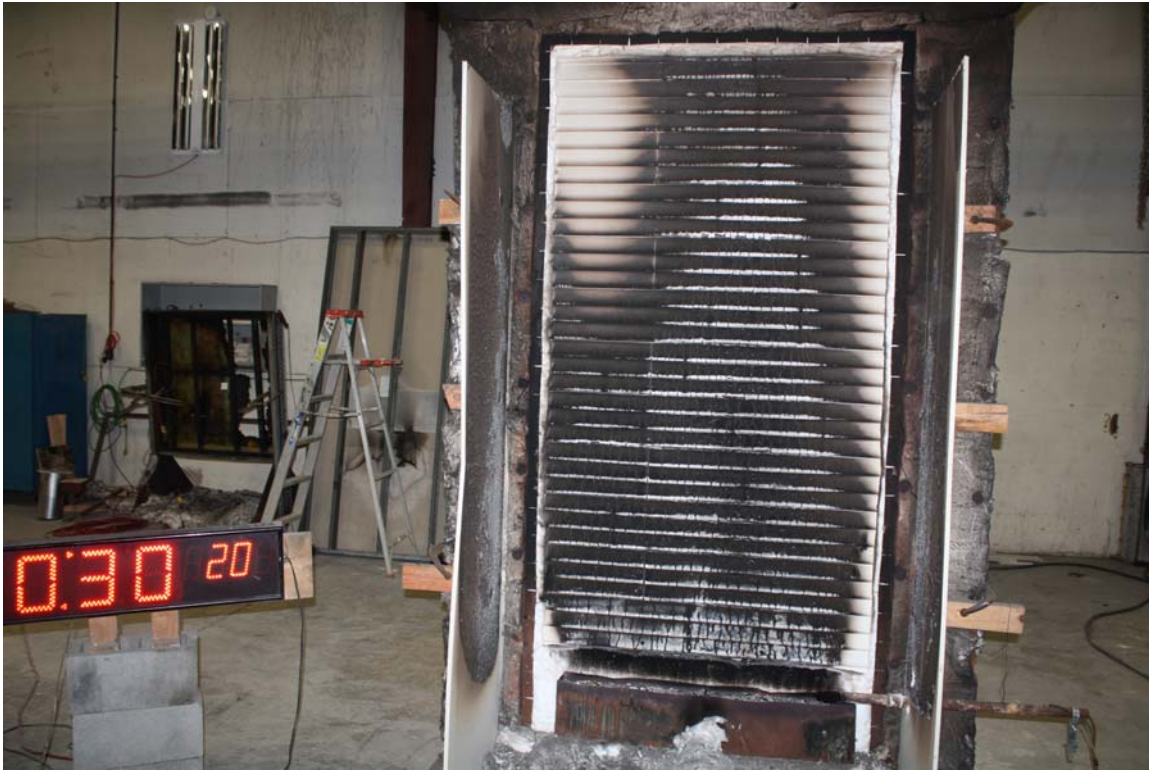
<b>Time</b>	<b>Observation</b>
0:00:00	Start Test, Ignite Burner
0:00:20	Ignition face
0:00:45	Flaming to soffit
0:10:00	Burner out- light flaming continues
0:11:00	Flames out, some glowing combustion on face
0:27:00	Glowing ceases
0:30:00	Temperatures diminishing, Stop test
Post Fire Exposure:	All signs of flaming and/or glowing combustion ceased prior to test termination; <b>no flaming or glowing combustion on unexposed side, test pass</b>
<b>Date</b>	10/21/09
<b>Burner Exposure</b>	150 kW
<b>Laboratory Temp/Humidity</b>	63F / 69%
<b>Sample Moisture Content</b>	Siding 9%, sheathing 6-7%; studs 9%

**Test 7, 3 lap at test termination**

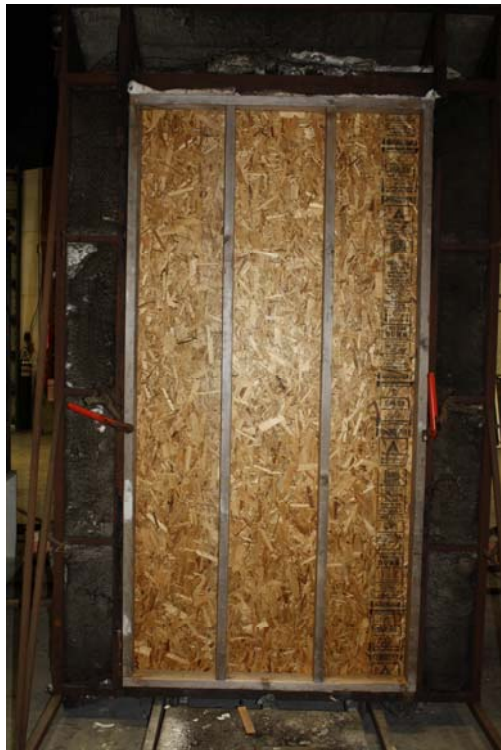
**3 lap, unexposed side at test termination**
